AFML-TR-67-293

# INVESTIGATION OF MAGNITUDE AND DISTRIBUTION OF STRESSES IN WELDED STRUCTURES

North American Aviation, Inc., Los Angeles Division

September 1967

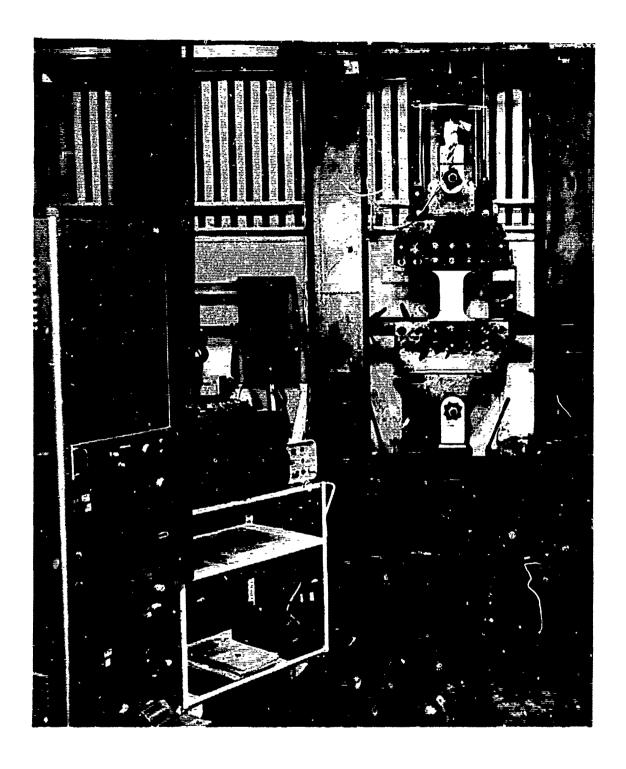
Figure 16. Fatigue Testing Setup

Fatiguing was performed in a servocontrolled hydraulic machine. All fatigue testing was axial tension-tension using a maximum to minimum stress ratio (R factor) of 0.06 and a maximum load of 60 percent of ultimate tensile strength at a load rate of three cycles per second. Figure 16 shows the equipment with a specimen mounted in the load plates.
